## Evaluation of fire in Stavanger airport car park 7 January 2020

Karolina Storesund, Christian Sesseng, Ragni F. Mikalsen, Ole Anders Holmvaag (Norwegian Fire Academy), Anne Steen-Hansen

RISE-report 2020:91

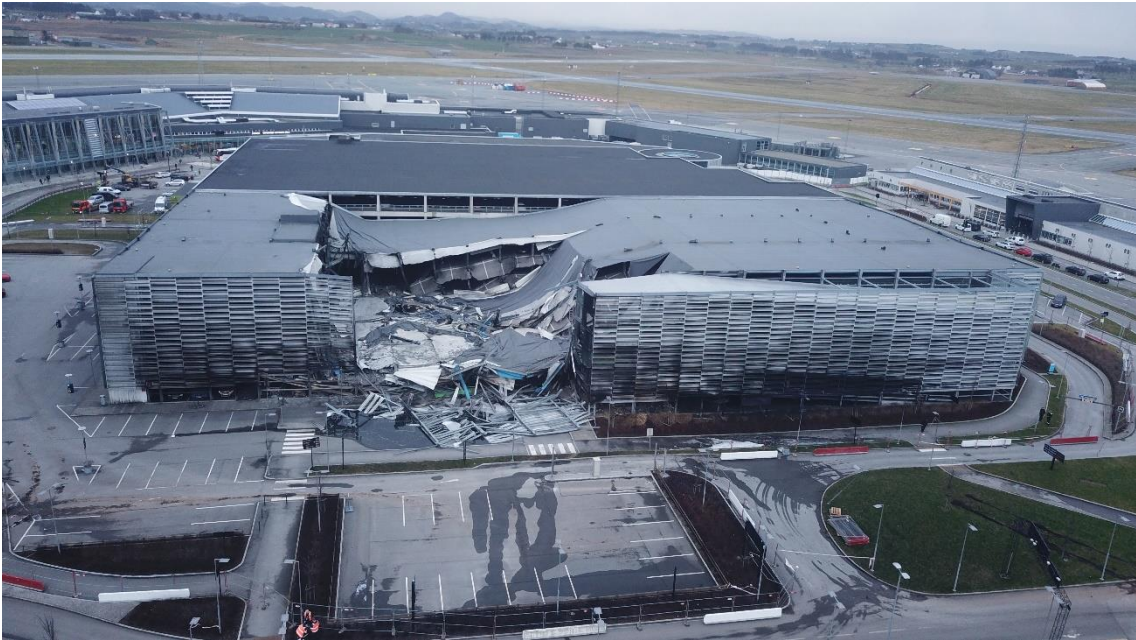
Figure 1-1 The car park at Stavanger airport Sola after the fire 7 January 2020. Photo: Nordic Unmanned.

On 7 January 2020 at approx. 15:25 hours a fire broke out in an Opel Zafira, parked on the ground floor in the car park at Stavanger airport Sola. The incident had huge financial consequences. The car park partly collapsed (Figure 1-1), several hundred vehicles were damaged, and the airport was shut down. Additionally, there were other safety related and financial consequences as a result of disruption of air traffic and spread of smoke to the airport area and surrounding areas.

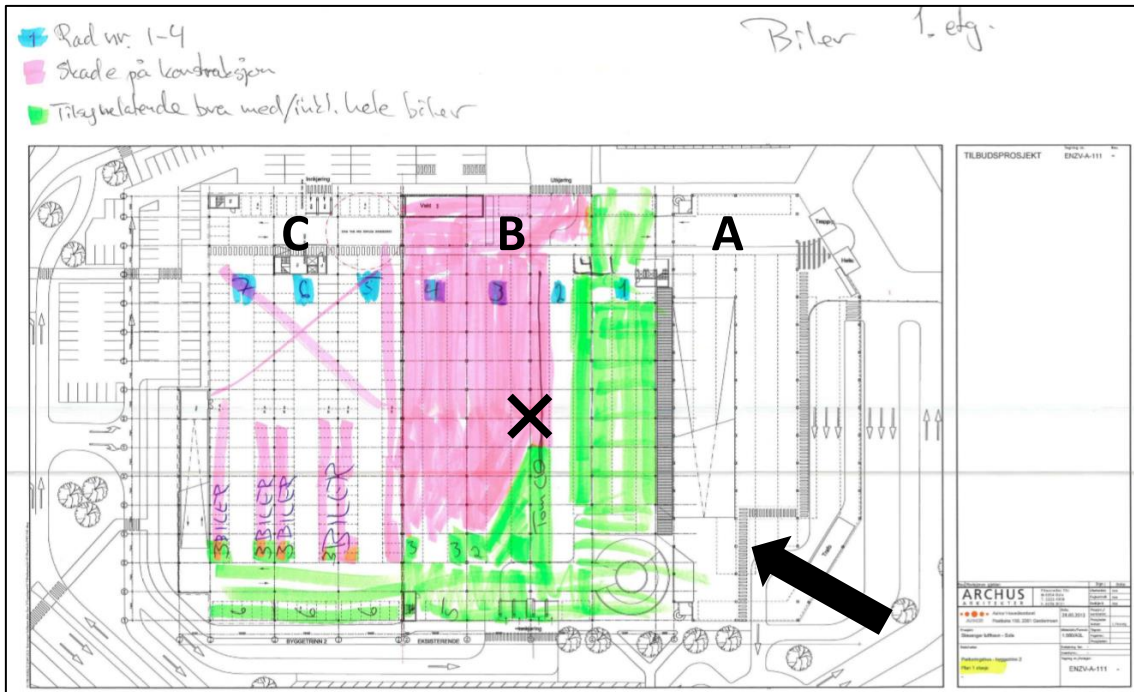
No lives were lost, and no one was injured in the incident. However, the fire led to huge material damage to the car park and the several hundred vehicles parked at the car park at the time of fire. Figure 2-2 shows the areas (pink marking) of the ground floor that had structural damage, and the parts that collapsed (pink cross). Further, the fire had ripple effects on air traffic as the airport had to shut down.

Figure 2-2 Sketch indicating areas on the car park ground floor with structural damage. Green indicates an apparently undamaged structure, while pink indicates a damaged structure. The pink cross indicates the collapsed area. The black cross shows location of the vehicle of origin. The arrow indicates the wind direction at start of fire (toward the north). The sketch was prepared by Nordic Unmanned on assignment from Avinor.

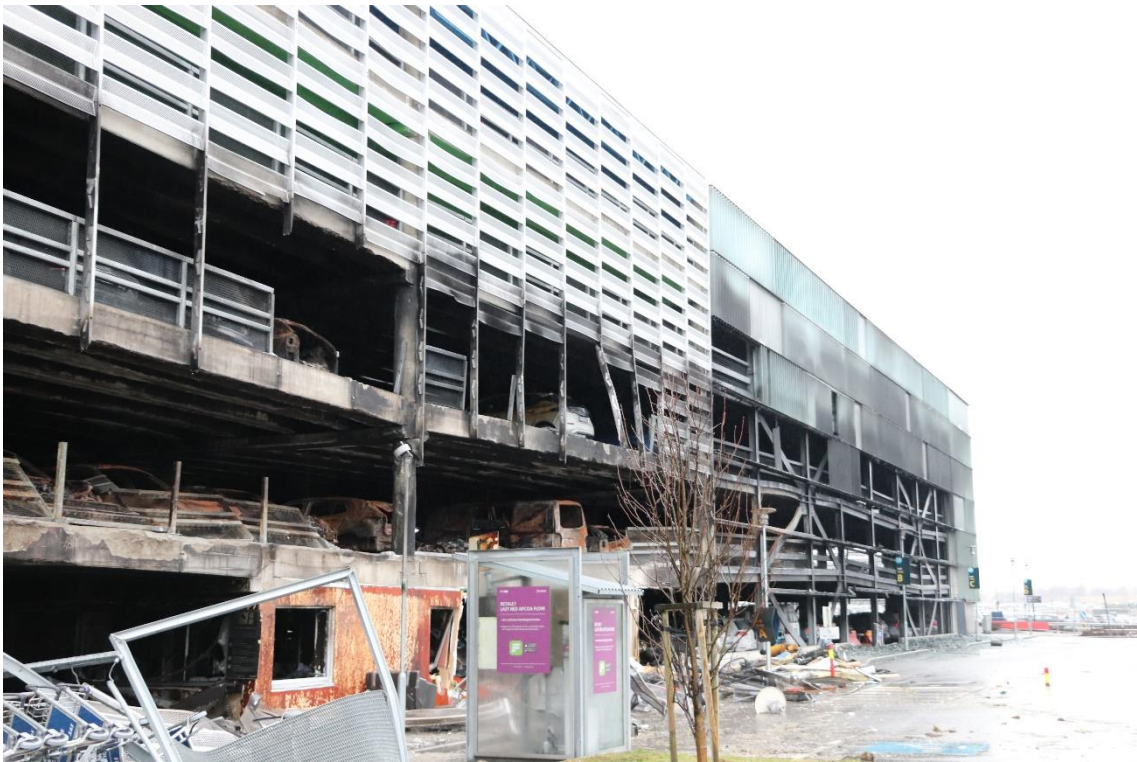
Figure 3-2 North-eastern part of car park after the fire. The left section shows building B and the right section building C.
